## Monitor National Marine Sanctuary Activities Report

# CHEESEBOX

Vol. 3, No. 1

### Conservation of the Monitor Anchor: Progress Report

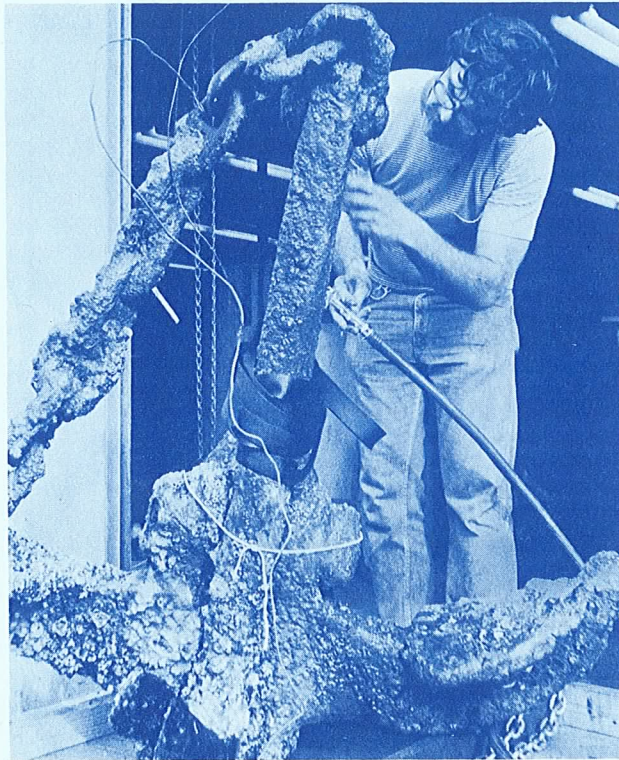
Conservator Curtiss Peterson examines the *Monitor* anchor during routine cleaning.

On November 7, 1983, the tank was drained and the anchor removed, cleaned, and examined. The encrustation was cracked and loosened around parts of the chain link adjacent to the shackle, re-

vealing an area of of reconstituted surface with the word "WOOD" cast into the crossbar of the link. The rest of the encrustation was intact and appeared to be in good condition. The tank and anodes were cleaned, the anodes were reattached, and the tank was refilled with electrolyte as before. The anchor appeared to be exhibiting satisfactory progress. The encrustation was still largely intact, indicating that reduction was not occurring so rapidly in places as to cause it to break apart.

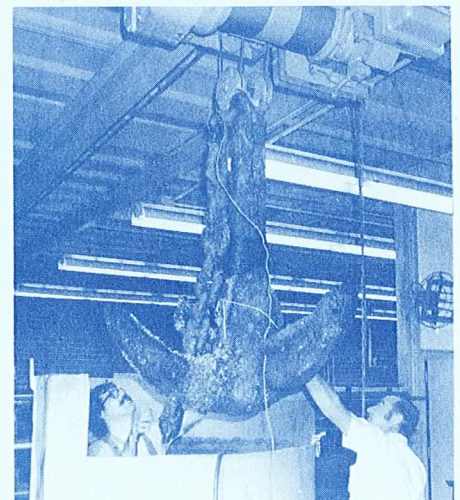
The anchor is carefully replaced in the conservation tank by Mr. Peterson with assistance from William Craft of East Carolina University.

The stainless steel mesh exhibited only slight deterioration, as was expected. The encrustation on the anchor was still largely intact. There was some loss on the tips of two flukes and on the chain link that bears the word "WOOD." Light tapping on the encrustation on the shaft and flukes revealed areas that sounded hollow, indicating that it was separating from the surface of the metal. Care is now being taken not to damage this fragile encrustation, as it still affords the reducing surface beneath some protection from free oxygen in the solution.

On February 25, 1984, the solution was changed and the anchor cleaned and examined. The encrustation on the anchor and chain is still largely intact with the exception of the "missing" side of the cast-with-the-shaft, half-palm fluke, where it is beginning to flake off. The encrustation on the shaft appears to be loosened over a larger area than on the last examination. Following completion of the examination the anodes were repositioned, the tank refilled, 7.6 kg of sodium hydroxide added to the solution, and the power supply turned on.

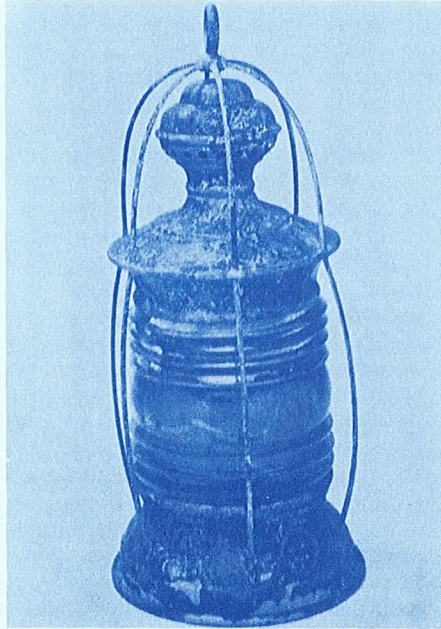
Conservation has now been completed on this brass navigation lantern recovered from the *Monitor* site in 1977.

The vent cap and top cover are composed of front sections shaped by spinning and joined mechanically by overlapping and interlocking with a rolling mill. The cap is perforated just below one of these joints to allow heat to escape. Large portions of the top cover are missing.

The glass lens accounts for most of the present weight of the lantern. Its Fresnel-type outer shell was mold-blown in a three piece mold: vertical seams are noted at 120° arc intervals. Its red color is due to an inner flashing of red glass blown into the clear lens body. The lens has suffered multiple breaks and cracks. The break pattern exhibits no impact point which would indicate a physical blow as the cause. Instead, the pattern of damage suggests a thermal shock; the hot lens of a lighted lantern being plunged into a cold, wintry sea.

A careful visual examination of the join between the base element and the lamp insert (visible through losses in the base as well as from underneath) led to the conclusion that the two elements were not fixed by corrosion as was previously thought. Wedges of 5 mil polyester sheet (Mylar) were inserted between the two elements to clear debris and ensure that they were not bonded by corrosion. A long copper rod was also employed through the areas of loss in the top element to loosen the tightly packed debris surrounding the top of the lamp insert. The insert was successfully removed after a few hours of careful cleaning. Approximately 600 grams of loose debris were also removed during and after removal of the lamp insert.

Burial accretions, fauna, and debris were removed mechanically. Approximately 60 grams of material were removed. Tools used included scalpels, glass-bristle brushes, nylon bristle brushes, and compressed air. The procedure was as follows: Coarse debris and accretions were removed with scalpel blades. Fine debris was then dislodged with a glass-bristle brush. Compressed air was employed to remove dust and brush splinters. Finally, a nylon bristle brush dipped in acetone was used to rinse and degrease the surface. The glass element was also cleaned using cotton wool and swabs moistened with a mixture of 10 parts deionized water, 8 parts ethanol, and one part ammonia, taking care that adjacent metal surfaces were not wetted.

The missing section of the foot ring was compensated by casting resin in a flexible tube with the proper inside diameter. The tube was secured in the proper curvature with clamps until the resin set. The tube was then cut away and the solid core was trimmed for installation.

The glass element received no further treatment. It would be unwise to introduce adhesives into the cracks unless those surfaces were first thoroughly cleaned. This cannot be accomplished without removal and disassembly of the lens element, which also cannot be accomplished without dismantling the exterior support cage. There is some solace in the fact that the housing locks all the pieces together.
